CIA IMA	GERY ANALYSIS DIVISI	ON	
NAME Ban Ken Hwy. Bridge over Nam Mat Bridge No. 1L on NE 48-2	Country Laos	19 35N - 103 40E PE 599664	 25X´
MAP JOG (A) 1501 NE 48-2		BRIEF NO: PIB 75200 October 1966	25X ²

CIA IMAGERY ANALYSIS DIVISION		
NAME	COUNTRY	COORDINATES
Ban Dong Hwy. Bridge		19 39N - 103 18E
Bridge No. 1L on NE 48-1	Laos	UG 224560
		BRIEF NO:
		PIB 75201
MAP JOG (A) 1501 NE 48-1		PIB 75201 October 1966

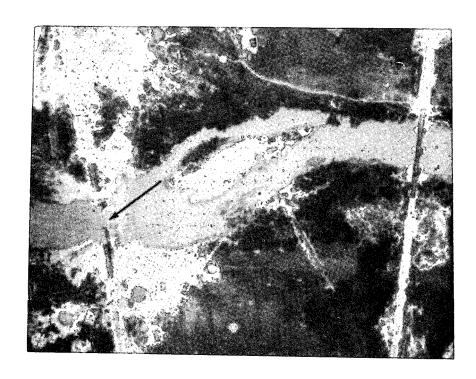
_	CIA IMAGERY ANALYSIS DIVISION				
-	NAME Cao	Nung RR. Bridge over	COUNTRY	COORDINATES	
25X1	Song Hao			21 33N - 106 29E	
_	Bridge No	o. 2 on NF 48-12	North Vietnam	XJ 554845	
25X1				BRIEF NO:	
				PIB 75202	
_	MAP	AMS L509 NF 48-12		October 1966	
	LOCATION:	0.4 nm SE of Cao Nung on th	ne Hanoi-Dong Dang Rail	Line.	
	DESCRIPTION	ı:			
25X1	LENGTH WIDTH Type	175' approx. Deck		ete, and timber 70' approx., 1 @ 60' approx 45' approx.	
	status: 2 sj	pans dropped (60! and 45!);	l span severely damage	a (70').	
	COMPENSATI	VE ACTION:			
	Bridge probably being repaired; deck of by-pass bridge has been replaced and now appears to be operational.				
25X1

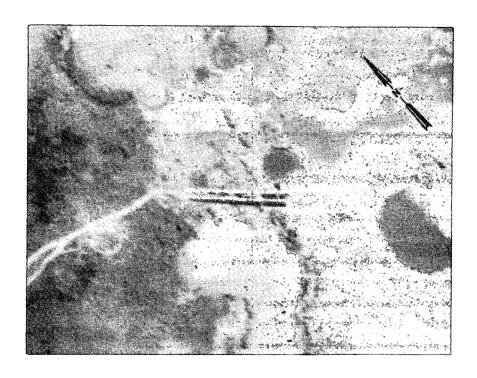
CIA	IMAGERY ANALYSIS DIVISION	
N AME	COUNTRY	COORDINATES
Xom Xoi Hwy. Bridge No. 2		17 37N - 106 29E
Bridge No. 14 on NE 48-11	North Vietnam	XE 566486
		BRIEF NO:
		PIB 75207
MAP JOG (A) 1501 NE 48-		October 1966
LOCATION: 0.2 nm NW of Xom Xoi	on Route 101.	
DESCRIPTION:		
LENGTH	MATERIAL WOOD	
WIDTH	mood	
TYPE	NO. OF SPANS 4	
Deck	ZENOTH OF EACH SPAN	
	_, L	
STATUS:		
Deck displaced off piers;	one abutment damaged; 3 p	iers damaged.
COMPENSATIVE ACTION:		
Dr. 2000		
By-pass causeway.		
by-pass causeway.		
by-pass causeway.

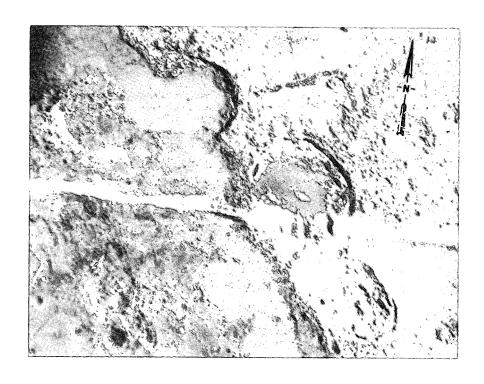
_		GERY ANALYSIS DIVISION		
25X1	NAME Kim Nac Hwy. Bridge over stream	COUNTRY	18 13N - 106 02E	_
	Bridge No. 23 on NE 48-7	North Vietnam	XF 103158	
25X1			BRIEF NO:	
	MAP JOG (A) 1501 NE 48-7		PIB 75208 October 1966	
	LOCATION: 0.8 nm NE of Kim Nac on	Route LA.		
25X1	DESCRIPTION:	Manala and		
20/(1	width 10 approx.	material Timber		
	Deck	LENGTH OF EACH SPAN		25X
	STATUS: Bridge is in late stages of	repair.		
	COMPENSATIVE ACTION:			
	By-pass bridge.			
25X1

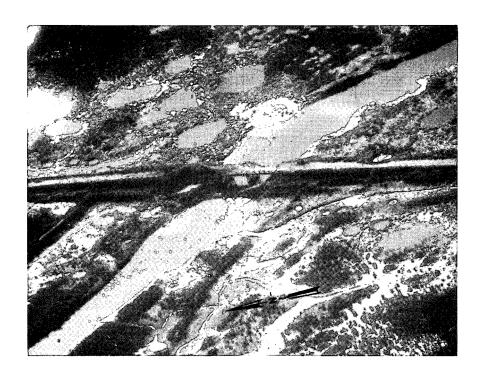
CIA IMAGE	RY ANALYSIS DIVISION	
	NAME Lan Tra Hwy. Bridge N over	COUNTRY	COORDINATES
5X1	Song Cua	İ	19 22N - 105 44E
	Bridge No. 21 on NE 48-3	North Vietnam	WG 771415
5X1			BRIEF NO:
			PIB 75210
	MAP JOG (A) 1501 NE 48-3		October 1966
	LOCATION: 1.0 nm W of Huu Lai on Rou	ute lA.	
	DESCRIPTION:		
	·	7	
X1	LENGTH	MATERIAL Concrete	and wood
	WIDTH TYPE	NO. OF SPANS 3	1
	Deck	LENGTH OF EACH SPAN	
	STATUS:		
	One span and 1 abutment destro	oyed; remaining 2 spans	s damaged.
	COMPENSATIVE ACTION:

None apparent.		
5X1			
//\ I

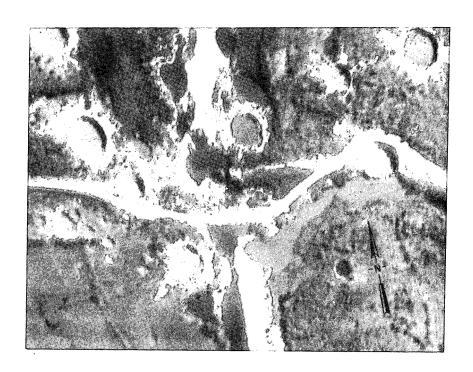
STATUS: Completely destroyed.

Ford

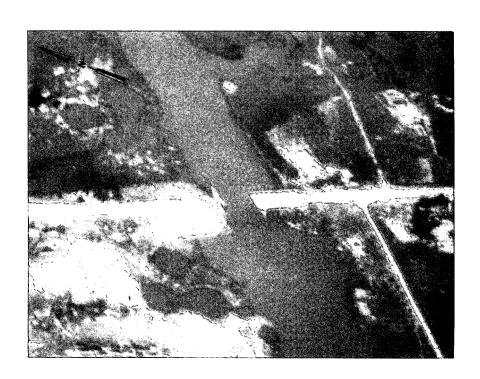
STATUS: 40' span destroyed; one 10' span destroyed; 1 pier slightly damaged.

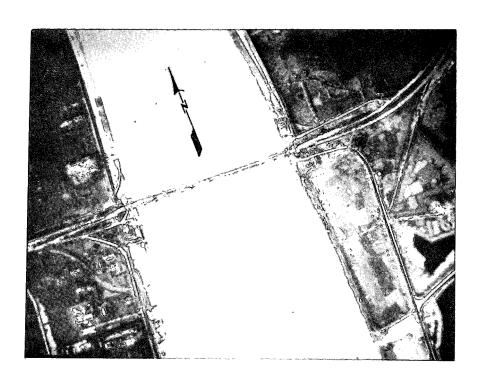
CIA IMAGE	ERY ANALYSIS DIVISION	
over Tha	Duong <u>RR. and Hwy. Bri</u> dge ai Binh No. 8 on NF 48-15	North Vietnam	20 56N - 106 21E XJ 415163
MAP	JOG (A) 1501 NF 48-15		BRIEF NO: PIB 75217 October 1966
LOCATION: DESCRIPTION LENGTH WIDTH	on: 1.290' approx.	MATERIAL Steel and	-
TYPE STATUS:	Single-track Combination through-arch t and temporary deck-beam dge repaired and serviceabl	russ	2 @ 125' approx. 2 @ 85' approx.
	TIVE ACTION: pass bridge under construct	ion north of bridge.

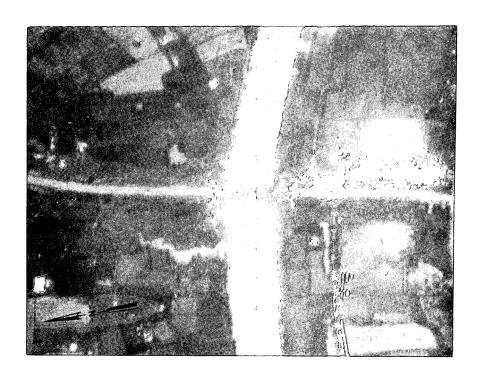
CIA IMAG	ERY ANALYSIS DIVISI	ION
over Hoang Giang Bridge No. 33 on		COUNTRY North Vietna	
MAP AMS JOG		. •	BRIEF NO: PIB 75219 October 1966
LOCATION: 0.8 nm	W of Thien Linh D	ong on Hanoi/Vinh	Rail Line.
LENGTH 80' app width TYPE Deck-gi		NO. OF SPANS	el and concrete
status: l span drop	ped; l pier severe	ely damaged; l sp	an severely damaged.
compensative action: By-pass bri	lge.

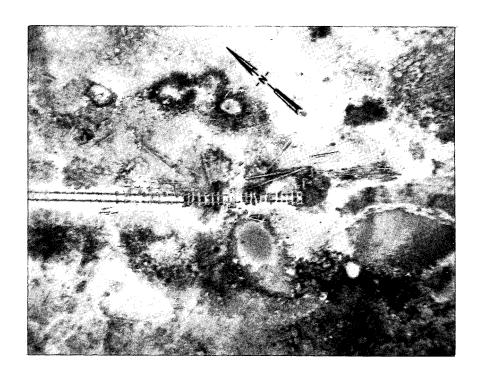
CIA IMA	GERY ANALYSIS DIVISION	
NAME		COUNTRY	COORDINATES
Trai :	Tranh Xom RR. Bridge		18 05N - 105 48E
Bridge	e No. 69 on NE 48-7	North Vietnam	WE 850993
			BRIEF NO:
			PIB 75220
MAP	JOG (A) 1501 NE 48-7		October 1966
LOCAT	ion: 0.7 nm NW of La Khe Thon	on the Vinh/Dong Hoi	Rail Line.
DESCRI	PTION:		
LENG	тн	MATERIAL Wood an	nd concrete
L ENG WIDTI			
TYPE	(Single-track	LENGTH OF EACH SPAN	
	Trestle		
CT 1 TUC			
STATUS	: L approach heavily cratered;	l abutment destroyed	: 1 span dropped.
•	approach heavily crasered;	i ababilit acbuilgea	, I phou arobbea.
COMPE	ISATIVE ACTION:		
]	None

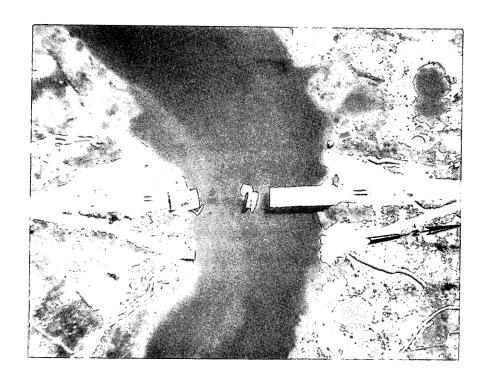
,	CIA IMAGE	RY ANALYSIS DIVISION		•
	NAME Tho Ngoa Hwy. Bridge over	COUNTRY	COORDINATES	
25X1	stream		18 14N - 106 OLE	
, .	Bridge No. 21 on NE 48-7	North Vietnam	XE 070170	
25X1			BRIEF NO:	
			PIB 75226	
	MAP JOG (A) 1501 NE 48-7		October 1966	
	LOCATION: 0.7 nm NW of Tho Ngoa on Ro	oute LA.		
	DESCRIPTION:			
25X1	LENGTH	MATERIAL Concrete and	steel	
25/(1	width 20' approx.	NO. OF SPANS 7		
	Deck	LENGTH OF EACH SPAN		25>
	2001			_0,
	STATUS:			
	Dropped spans replaced by cable	es; no evidence of remo	veable decking.	
	COMPENSATIVE ACTION:			
	NA			
	TATA			
_				
25X1

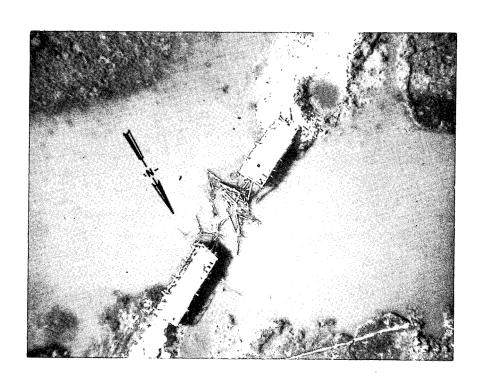
Three spans and 2 piers destroyed; 4 spans moderately damaged; both abutments severely damaged.

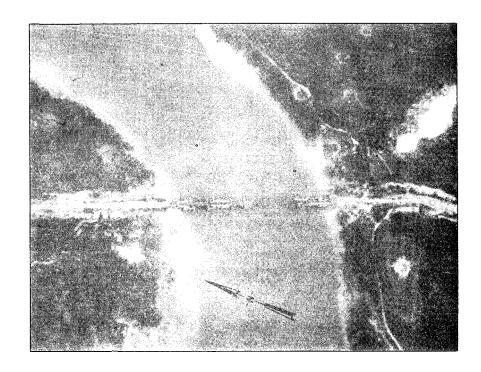
Three spans destroyed; two spans possibly damaged.

By-pass bridge No. 2 remains serviceable; by-pass bridge No. 3 under construction.

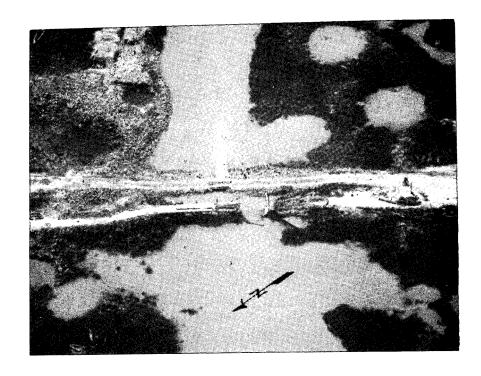
CIA	IMAGERY ANALYSIS DIVISION		
N AME		COUNTRY	COORDINATES	
Dong Bai Hwy. Brid			19 08N - 105 37E	
Bridge No. 11 on N	E 48-3	North Vietnam	WG 656166	
***			PIB 75231 October 1966	
LOCATION: 0.8 nm NE	NE 48-3 l of Cao Hau c	on Route LA.	October 1900	
DESCRIPTION:				
LENGTH 95' appro	ox.	MATERIAL Steel and	concrete	
TYPE 10' appro		NO. OF SPANS 4 Length of Each Span		
status: One span dest	royed.			
COMPENSATIVE ACTION:				
Rock filled o	auseway by-pa	ass.

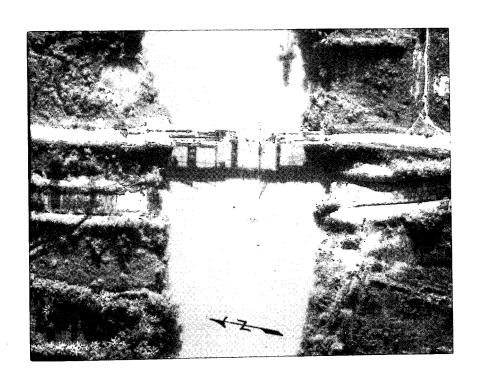
-		CIA IMAGE	RY ANALYSIS DIVISION			
- 5X1	Song Yen	Thi Hwy. Bridge over	COUNTRY	coordinates 19 37N - 105 39E WG 679699		
5X1	Bridge N	o. 55 on NE 48-3	North Vietnam	BRIEF NO: PIB 75233		
-	MAP LOCATION:	JOG (A) 1501 NE 48-3 At An Trach on Route 704.		October 1966		
	DESCRIPTION		•			
	LENGTH Width Type	100' approx. 10' approx. Deck	material Wood and no. of spans 14 Length of each span	concrete 2 @ 35' approx.		
	status: Bri	dge in late stages of repai	ir.	2 @ 15' approx.		
	COMPENSATIVE ACTION:					
	2 p	ontoon by-pass bridges; one	e ford.			
5X1

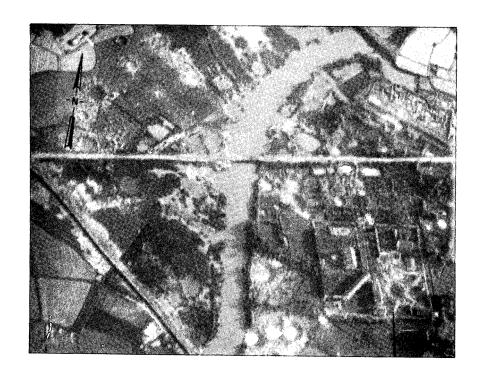
CIA IN	MAGERY ANALYSIS DIVISION	
X1	NAME Vinh Luu Hwy. Bridge over Song Chau Lam Bridge No. 31 on NE 48-7	COUNTRY North Vietnam	COORDINATES 18 20N - 105 53E WF 928278
(1			BRIEF NO:
	MAP JOG (A) 1501 NE 48-7		PIB 75235 October 1966
	LOCATION: 1.1 nm SE of Thanh True	ai on Route 15.	
	DESCRIPTION:		
X1	width type Deck	material Wood no. of spans 6 proba Length of each span 20	ble approx.
	STATUS: Bridge repaired and service	ceable.	
	COMPENSATIVE ACTION:		
	By-pass road and possible	ferry site.	
X1

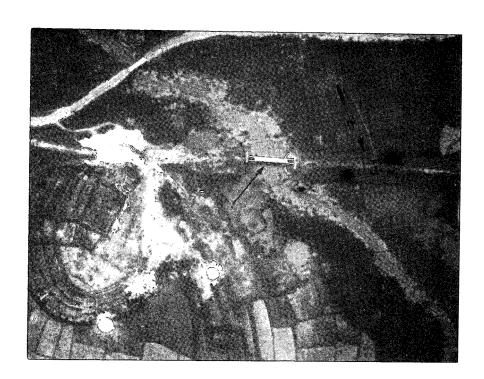
Bridge repaired; serviceable for highway traffic.

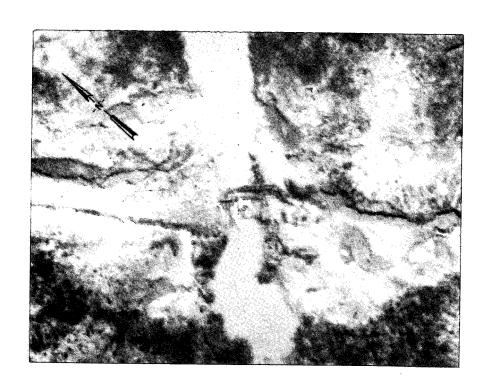
5 spans destroyed; 1 span lightly damaged; 1 span severely damaged; 2 piers destroyed; 3 piers moderately damaged.

By-pass road and ford.

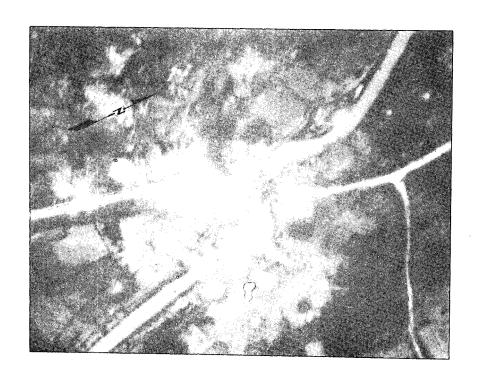
N AME	COUNTRY	COORDINATES
Hau Thach Hwy. Bridge		19 29N - 105 47E
Bridge No. 15 on NE 48-3	North Vietnam	WG 837543
		BRIEF NO:
		PIB 75250
MAP JOG (A) 1501 NE 48-	•3	October 1966

STATUS: Decking damaged.

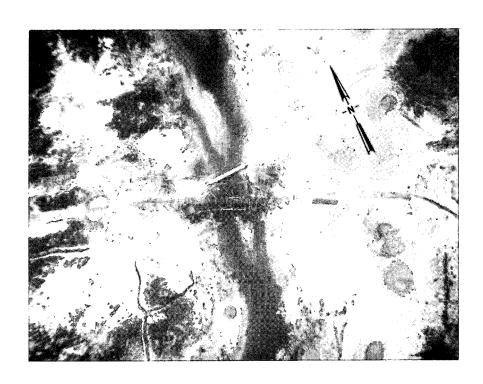
•	•	CIA IMAGER	RY ANALYSIS DIVISION	
25X1	Khe Net	Khe RR. Bridge over o. 11 on NE 48-11	COUNTRY North Vietnam	COORDINATES 17 58N - 105 56E WF 987978
25X1	MAP	JOG (A) 1501 NE 48-11		BRIEF NO: PIB 75251 October 1966
•		0.2 nm SW of Xom Khe on the	e Vinh/Dong Hoi Rail Li	
	DESCRIPTIO	N:		
25X1	LENGTH WIDTH Type	200' approx. Single -track) Deck-beam bridge supported by lattice towers	material Timber no. of spans 4 length of each span 50	o' approx.
	STATUS:		٦	
	Rep	laced and possibly serviceab	ole.	
	COMPENSAT	IVE ACTION:		
	con	ood, deck-type bridge suppor structed at the bridge site. ment of track over the brids	There is no connecti	on between the short

be used to shuttle material over the river.

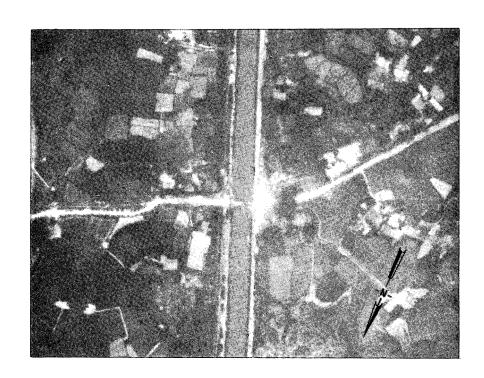
CIA IMA	GERY ANALYSIS DIVISION	
N	NAME	COUNTRY	COORDINATES
	Phuong Do Hwy. Bridge		21 28N - 105 57E
_E	Bridge No. 15 on NF 48-11	North Vietnam	WJ 992748
5X1 Г			BRIEF NO:
•/ .			PIB 75252
	MAP AMS JOG (A) 1501 NF 48	3-11	October 1966

l span dropped.

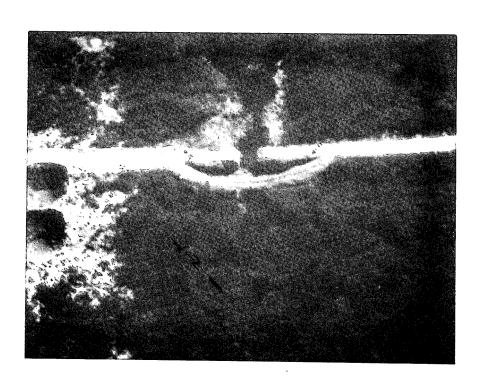
CIA IMAGE	ERY ANALYSIS DIVISION		
•	NAME	COUNTRY	COORDINATES	
	Hoang Le Hwy. Bridge Bridge No. 47 on NE 48-11	North Vietnam	17 59N - 106 28E XE 550805	
25X1			BRIEF NO: PIB 75253	
	MAP JOG (A) 1501 NE 48-11		7 October 1966	
	LOCATION: 1.3 nm NW of Hoang Le on I	Route LA.		_
	DESCRIPTION:			
25X1	LENGTH WIDTH	MATERIAL Concrete		
	TYPE Deck	LENGTH OF EACH SPAN		25X1
	Span destroyed; abutments into	act.

Ford

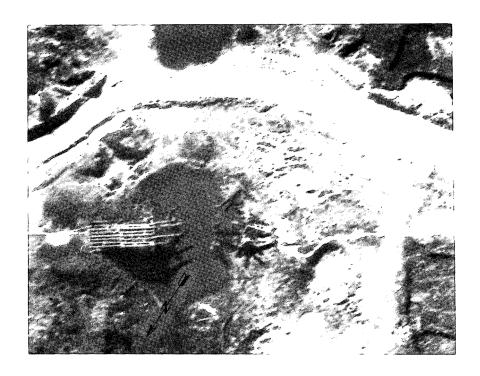
CIA IMA	GERY ANALYSIS DIVISION	
NAME Don	g Lac Hwy. Bridge No. 2	COUNTRY	COORDINATES
over Bau			18 11N - 106 10E
Bridge No	. 65 on NE 48-7	North Vietnam	XF 238117
			BRIEF NO:
			PIB 75255
MAP	JOG (A) 1501 NE 48-7		October 1966
LOCATION:	0.3 nm SSW of Son Kinh c	n unnumbered route.	
DESCRIPTIO	N:		
LENGTH Width Type	100' approx. Deck	material Concret no. of spans 5 length of each span	e and wood
status: 3.sp	ans destroyed; piers dama		
COMPENSATI	VE ACTION:		
Ford

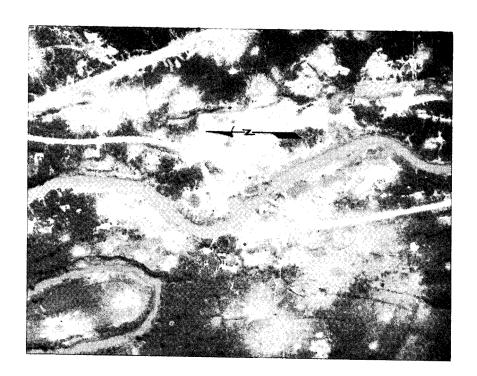
•	CIA	IMAGERY ANALYSIS DIVISION		
N AME		COUNTRY	COORDINATES	
Thach Luyen Hwy			19 19N - 105 43E	
Bridge No. 31 o	n NE 48 - 3	North Vietnam	WG 758370	
5X1			BRIEF NO:	
3/11			PIB 75258	
map AMS JO	G (A) 1501 NE	E 48-3	October 1966	
LOCATION: At Tha	ch Luyen on Rou	ite No. 1A.		
DESCRIPTION:				
5X1 LENGTH		MATERIAL Concrete		
WIDTH		NO. OF SPANS 6		
TYPE Deck		LENGTH OF EACH SPAN		25X
Deck				25/
0747115				
status: Bridge des	troved.	<u> </u>	<u> </u>	
	5_ 5, 5 a •			
COMPENSATIVE ACTIO	N:			
None				
EV4				
5X1

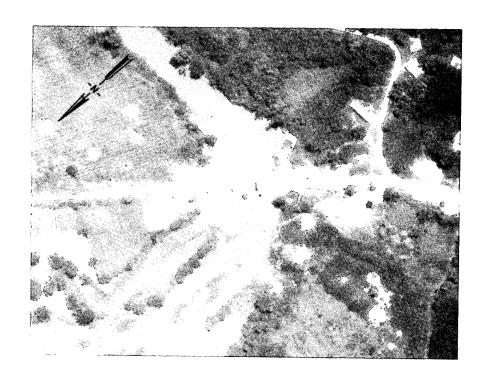
-	CIA IMAGER	RY ANALYSIS DIVISION		
25X1	Cho Moi Hwy. Bridge over Song Cho Bridge No. 1 on NF 48-11	COUNTRY North Vietnam	COORDINATES 21 52N - 105 46E WK 802195	
25X1	MAP JOG (A) 1501 NF 48-11 LOCATION: 0.4 nm SW of Cho Moi on Rou		BRIEF NO: PIB 75259 October 1966	
25X1	DESCRIPTION: LENGTH WIDTH TYPE Deck STATUS: Bridge destroyed.	MATERIAL Concrete NO. OF SPANS 3 LENGTH OF EACH SPAN		25X 1
	compensative action: Bridge is in early stages of r	econstruction.		
25X1

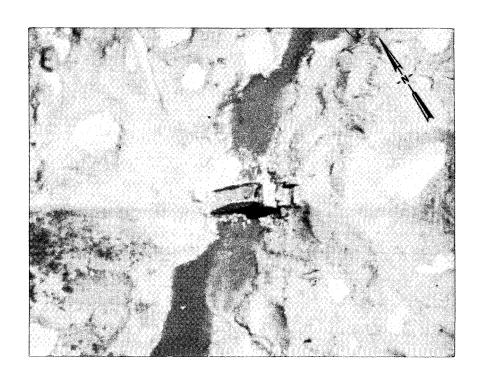
l abutment destroyed; one 25' span destroyed; l pier destroyed; 60' span dropped.

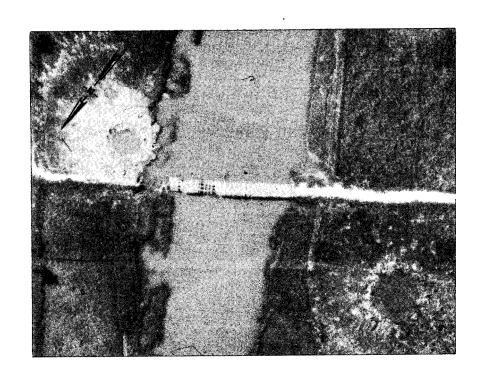
CIA IMAG	ERY ANALYSIS DIVISION	
N AME	COUNTRY	COORDINATES
Ham Hoa Hwy. Bridge		17 03N - 107 00E
Bridge No. 59 on NE 48-12	North Vietnam	YE 148875
5X1		BRIEF NO:
^		PIB 75261
MAP JOG (A) 1501 NE 48-12		October 1966

2 spans dropped.

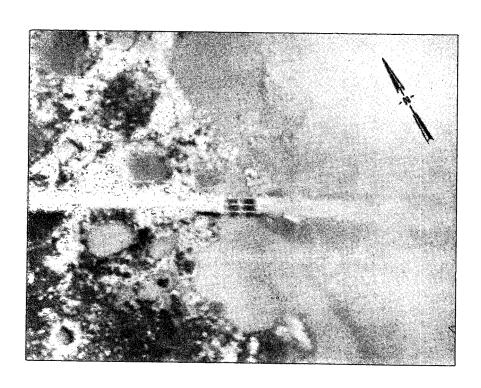
CIA IMAGERY ANALYSIS DIVISION			
	NAME Thuan Le Hwy. Bridge over	COUNTRY	COORDINATES	
25X1	Khe Thuong Loc		18 13N - 106 04E	
	Bridge No. 66 on NE 48-7	North Vietnam	XF 143146	
25X1			BRIEF NO:	
20/(1			PIB 75264	
	MAP JOG (A) 1501 NE 48-7		October 1966

Bridge is in late stages of repair.

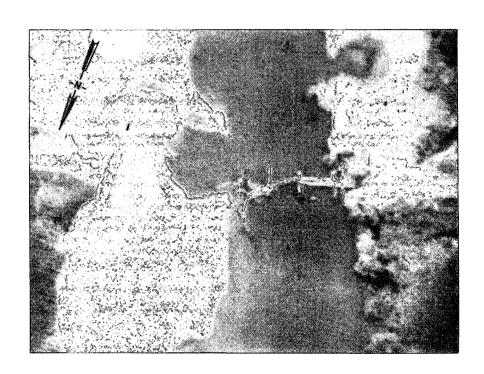
CIA IMAGE	RY ANALYSIS DIVISION		_ _
25X1	NAME Dong Bai RR. By-pass Bridge Nover Song Tien Bridge No. 11 on NE 48-7	COUNTRY North Vietnam	COORDINATES 18 09N - 105 43E WF 763083	
25X1	MAP JOG (A) 1501 NE 48-7 LOCATION: 0.4 nm NNE of Dong Bai on V	inh/Dong Hoi Rail line	BRIEF NO: PIB 75265 October 1966	
25X1	DESCRIPTION: LENGTH WIDTH Single-track)	MATERIAL Steel, WOO		25X1
	Removeable deck beam status: 9 spans destroyed; 5 piers desseverely damaged.	LENGTH OF EACH SPAN		
	compensative action: None			
25X1

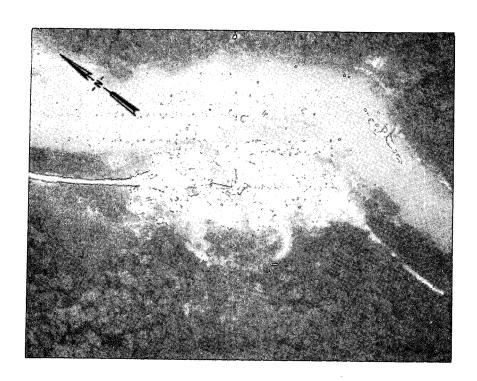
_	CIA IMAGERY ANALYSIS DIVISION			
	NAME Ban Houei Cui Hwy. Bridge	COUNTRY	COORDINATES	
25X1			19 19N - 104 20E	
	Bridge No. 7 on NE 48-2	North Vietnam	VG 298357	
5X1			BRIEF NO:	
			PIB 75269	
	MAP JOG (A) 1501 NE 48-2		October 1966	
	LOCATION: 1 nm NW of Ban Houei Cui on	Route 7.		
	DESCRIPTION:			
.5X1	WIDTH 70' approx.	mater:al Concrete no. of spans 3 LENGTH OF EACH SPAN 7 @	F01 .	
	Deck		50' approx. 10' approx.	
	One 10' span dropped; 50' span	n dropped; one 10' span	moderately damaged.	
	COMPENSATIVE ACTION:			
	By-pass bridge.			
25X1

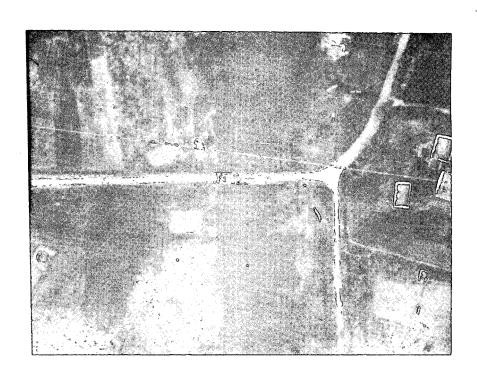
Moderate deck damage.

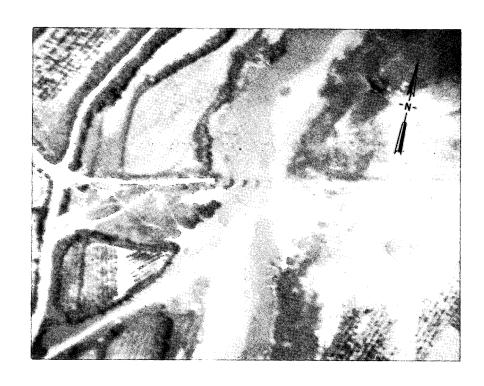
IMAGERY ANALYSIS DIVISION		_
NAME Ky Anh Hwy. Bridge over	COUNTRY	COORDINATES	_
Song Cau Tri		18 04N - 106 16E	
Bridge No. 57 on NE 48-7	North Vietnam	XE 342980	
1		BRIEF NO:	_
		PIB 75271	
LOCATION: 1.5 nm SW of Bieu Due		October 1966	
LENGTH WIDTH TYPE	MATERIAL Probable	wood	2
Deck	LENGTH OF EACH SPAN		4
status: 5 spans destroyed.			
COMPENSATIVE ACTION:

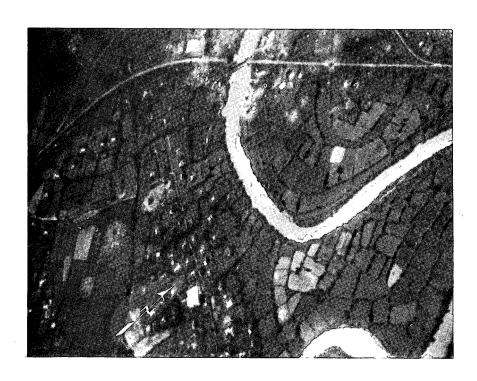
-						
	CIA IMAGERY ANALYSIS DIVISION					
05V4	NAME Dai Khe Dau	Thuy RR. Bridge SW over	COUNTRY	COORDINATES		
25X1 -		o. 17 on NE 48-3	North Vietnam	19 23N - 105 43E WG 756417		
25X1				BRIEF NO:		
_	MAP	JOG (A) 1501 NE 48-3		PIB 75274 November 1966		
_	LOCATION: 0.5 nm SE of Dong Ky on the Hanoi/Dong Hoi Rail Line. DESCRIPTION:					
25X1 WIDTH 115' approx. MATERIAL Steel and concrete No. of Spans 1				l concrete		
23/(1	TYPE	Half-through truss		115' approx.		
	status: Spa	n dropped.

compensative action:
None

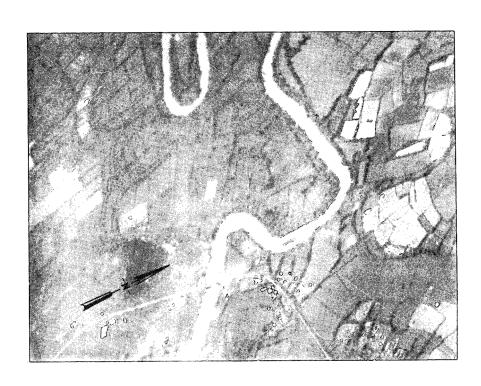
Two spans completely destroyed.

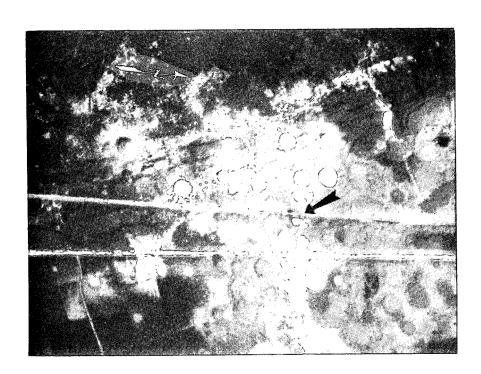
_	CIA IA	MAGERY ANALYSIS DIVISION	
	NAME	COUNTRY	COORDINATES
	Huu Lei RR. Bridge Bridge No. 51 on NE 48-3	North Vietnam	19 22N - 105 44E WG 780429
	DITURE NO. /I OH III , O. /		BRIEF NO:
25X1			PIB 75276
L	MAP JOG (A) 1501 NE 48-3	3	November 1966

Repaired and probably serviceable.

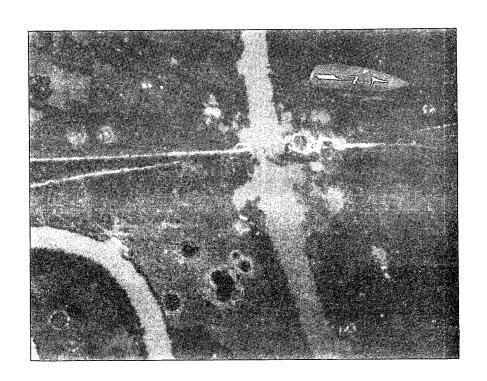
-	CIA IMAGERY ANALYSIS DIVISION				
-	NAME Thi	Long RR. Bridge over	COUNTRY	COORDINATES	
25X1	Suoi Cay			19 31N - 105 42E	
-	Bridge No	o. 2 on NE 48-3	North Vietnam	WG 742599	
25X1				BRIEF NO:	
		700 (1) 7505 757 10 0		PIB 75277	
-	MAP	JOG (A) 1501 NE 48-3		November 1966	
	LOCATION:	O.1 nm SE of Thi Long on t	he Hanoi/Dong Hoi Ra	ail Line.	
	DESCRIPTION	:			
	LENGTH	100' approx.	material Steel		
25X1	WIDTH Type	(Single track) NO. OF SPANS 2 LENGTH OF EACH SPAN		
	=	Through-truss	ZENOTH OF EXONOLAR	1 @ 25' approx.	
				1 @ 75' approx.	
	STATUS:				
	All	spans destroyed.			
	COMPENSATIV	/E ACTION:			
	None	9			
25X1

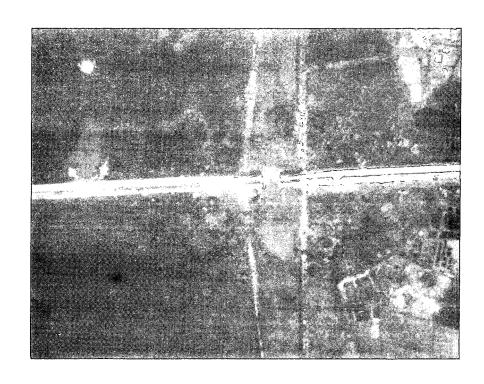
• • • • • • • • • • • • • • • • • • • •	SERY ANALYSIS DIVISION	
NAME Dong Khe I	RR. and Hwy. Bridg	e COUNTRY	COORDINATES
S over canal			19 04N - 105 35E
Bridge No. 27 on	NE 48-3	North Vietnam	WG 618081
1			BRIEF NO:
			PIB 75278
MAP JOG (A)	1501 NE 48-3		October 1966
LOCATION: 0.8 nm	N of Dong Khe on t	he Hanoi/Dong Hoi Rai	l Line.
DESCRIPTION:			
LENGTH 120' app	nrov	material Steel an	d concrete
WIDTH	51.02.	NO. OF SPANS 3	
TYPE Deck		LENGTH OF EACH SPAN	40' approx.
STATUS:	an completely dest	xo ved	
Cettoer pho	an combregery dead	royeu.	
-			
_			
COMPENSATIVE ACTION:

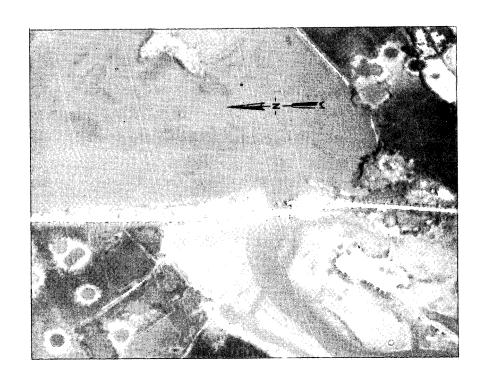
_		CIA IMAGER			
_	NAME Qui	My Hwy. Bridge S over	COUNTRY	COORDINATES	
25X1	stream	11/ 12/1/		19 24N - 105 45E	
20/(1	Bridge N	o. 50 on NE 48-3	North Vietnam	w g 800460	
25X1	212080			BRIEF NO:	
				PIB 75280	
•	MAP	JOG (A) 1501 NE 48-3		November 1966	
-	LOCATION:	0.5 nm S of Qui My on Rout	e lA.		
	DESCRIPTION		MATERIAL Timber		
	LENGTH	75' approx.	no. of spans 5 approx.		
	WIDTH Type	10' approx.	LENGTH OF EACH SPAN 15	approx.	
	• • • •	Deck	-/	o.E.E.	
			•		
	STATUS:	aseway at site of original b	oridge.		
	Oac	rpeway as broc or orrestrant			
	COMPENSATI	VE ACTION:			
25X1	Des	stroyed by-pass bridge	replaced by a r	ock filled causeway.	
0EV4					
25X1

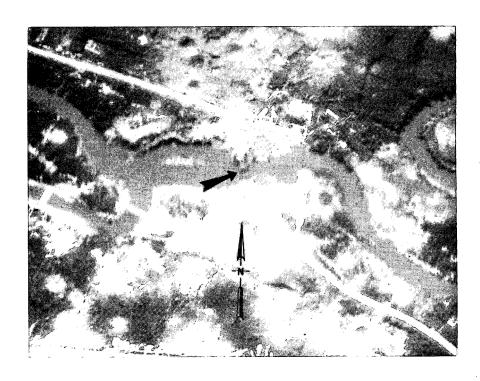
rth Vietnam	COORDINATES 19 19N - 105 43E WG 758370 BRIEF NO: PIB 75281 November 1966	
aterial Wood	WG 758370 BRIEF NO: PIB 75281	
aterial Wood	BRIEF NO: PIB 75281	
· · - · · · · ·	PIB 75281	
· · - · · · · ·		
· · - · · · · ·	I November 1966	
· · - · · · · ·		
· · - · · · · ·		
· · - · · · · ·		
O. OF SPANS 3		
NGTH OF EACH SPAN		2
k sections obse	erved.	
	ENGTH OF EACH SPAN	ek sections observed.

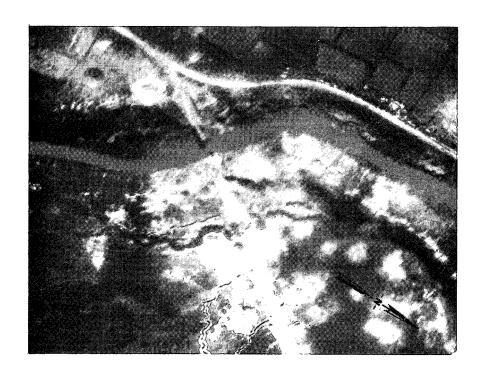
By-Pass No. 1

Two spans destroyed; one abutment destroyed.

Main bridge (NE 48-3-31) is repaired and serviceable.

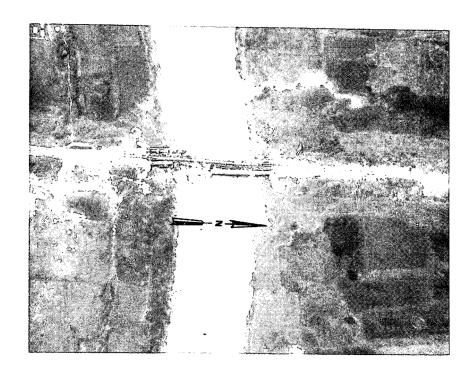
CIA IMAGERY ANALYSIS DIVISION				
-	N AME		COUNTRY	COORDINATES	
	Thien Li	nh Dong RR. Bridge		19 43N - 105 42E	
-	Bridge N	[0. 33 on NE 48-3	North Vietnam	XG 748815	
25X1				BRIEF NO:	
	MAP	TOO (A) TOO MIT DO		PIB 75285	
-	LOCATION:	JOG (A) 1501 NE 48-3		November 1966	
	200mmon.	0.5 nm N of Thien Linh Do	ong on Hanoi/Vinh Rail	Line.	
	DESCRIPTION	l:			
	LENGTH	80' approx.	MATERIAL Steel a	and concrete	
25X1	WIDTH		NO. OF SPANS 2		
	TYPE	Deck-girder	LENGTH OF EACH SPAN	40' approx.	
		G			
	STATUS:	a 2			
	Bri foo	dge replaced by temporary	deck-type bridge; ser	viceable to rail and	
	100	t traffic.	•		
	COMPENSATI	VE ACTION:			
	NA				
25.74					
25X1

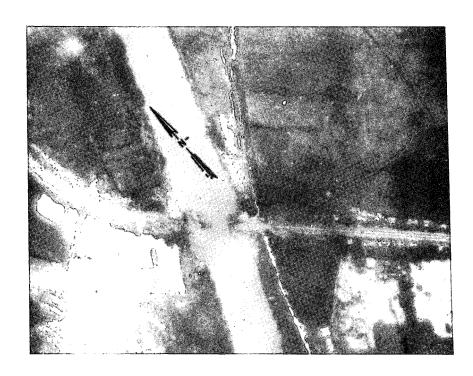
Spans destroyed.

None; main rail bridge is serviceable.

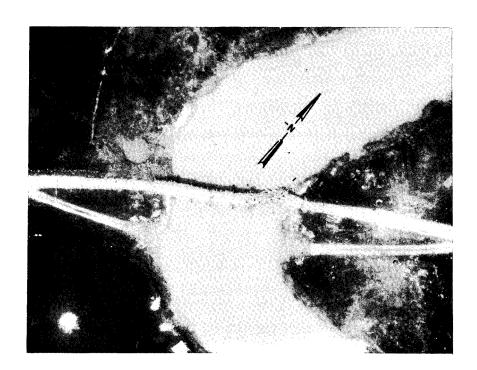
CIA II	MAGERY ANALYSIS DIVISION		
over Vi	ien Linh Dong Hwy. Brid Giang No. 32 on NE 48-3	ge COUNTRY North Vietnam	COORDINATES 19 43N - 105 42E WG 752806	
MAP	JOG (A) 1501 NE 48-	3	PIB 75287 November 1966	
LOCATION:	0.5 nm SSW of Thien L	inh Dong on Route 704.		
DESCRIPTION LENGTH WIDTH TYPE	10' approx. Deck	MATERIAL WOOD NO. OF SPANS 8 LENGTH OF EACH SPAN		
status:	spans dropped; one pier	destroyed.		
COMPENSAT	IVE ACTION:

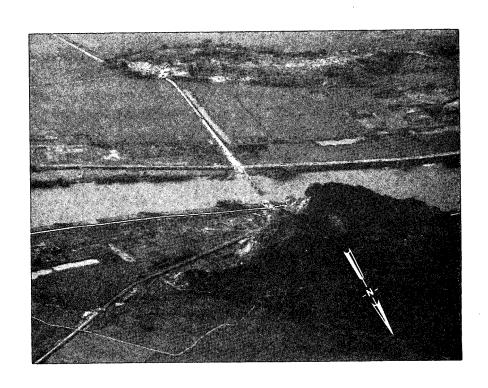
_	CIA	IMAGERY ANALYSIS DIVISION	
-	NAME Dong Phuong Thuong RR. I		COORDINATES
X1	S over Song Len		19 58N - 105 49E
/\ I	Bridge No. 6 on NE 48-3	North Vietnam	хн 864077
X1 -	Di Lugo Mor i de		BRIEF NO:
/\ I			PIB 75288
	MAP JOG (A) 1501 NE 48		November 1966
•	LOCATION: 1 nm W of Ngoc Tu or	n Hanoi/Dong Hoi Rail Line.	
	DESCRIPTION:		
	LENGTH 270 approx.	material Timber	
X1	width (Single	e track) no. of spans 6	
	TYPE Deck	e track) Length of Each Span 45	'approx.
	STATUS:		
	2 spans and 1 pier dest:	royed.

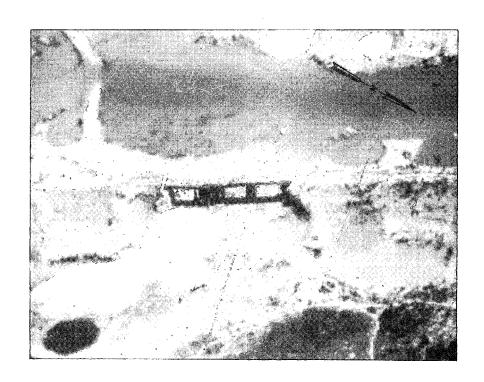
Bridge repaired by the addition of reinforcing piers.

One pier probably damaged; serviceable.

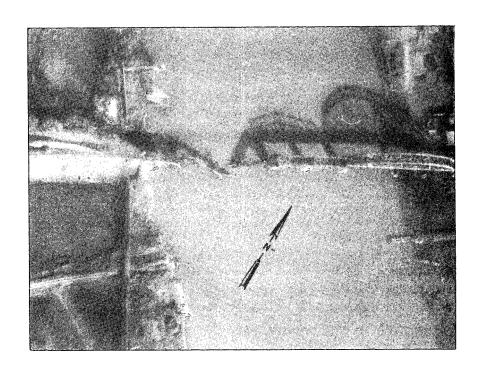
CIA IMAGERY ANALYSIS DIVISION					
•	NAME Ninh Binh RR. and Hwy.	Bridge COUNTRY	COORDINATES			
25X1	over Song Day		20 15N - 105 59E			
	Bridge No. 1 on NF 48-15	North Vietnam	ХН 030405			
25X1			BRIEF NO:			
			PIB 75292			
	MAP JOG (A) 1501 NF	48-15	November 1966			
	LOCATION: At Ninh Binh on Ro	oute 10.				
	DESCRIPTION:					
25X1	WIDTH TYPE Through-truss W/ce	I ENGTH OF FACH SPAN O	inuous trussed and center			
	swing span status: 3 spans dropped; one p	pier destroyed; one pier damaged	a .			
	compensative action: Railroad by-pass bridg	ge under construction east of ma	ain bridge.

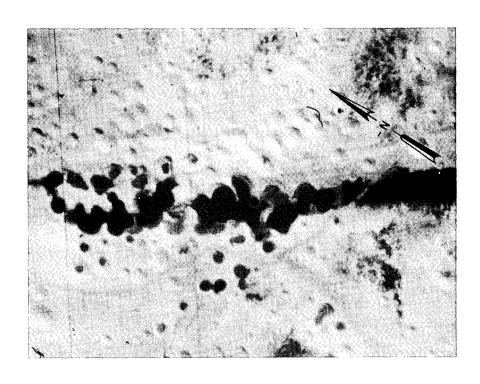
_		CIA IMAG	ERY ANALYSIS DIVISION	
_	NAME Reli	Khe Hwy. Bridge over	COUNTRY	COORDINATES
	stream	inite inv.y : Di rage o vor		17 40N - 106 30E
		o. 15 on NE 48-12	North Vietnam	XE 601538
T	DI LUEC I	O		BRIEF NO:
				PIB 75293
-	MAP	JOG (A) 1501 NE 48-12		November 1966
_	LOCATION:	1.6 nm NW of Ly Hoa on R	Route LA.	
	DESCRIPTION	l:		
	LENGTH WIDTH	30' approx.	MATERIAL Wood	
	TYPE	Deck-beam	LENGTH OF EACH SPAN	30' approx.
	STATUS:			
	Con	pletely destroyed.		
	COMPENSATI	VE ACTION:		
	For	· d

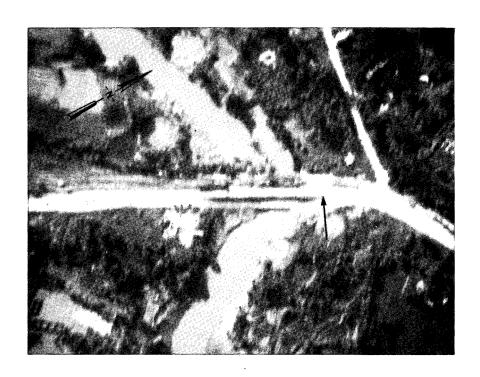
CIA IMAGERY ANALYSIS DIVISION				
	NAME Yen Bai Hwy. Bridge over	COUNTRY	COORDINATES		
25X1	Ngoi Cuong No		21 42N - 104 53E		
	Bridge No. 36 on NF 48-10	North Vietnam	VJ 881999		
25X1			BRIEF NO:		
			PIB 75294		
	MAP JOG (A) 1501 NF 48-10		November 1966		
	LOCATION: 0.4 nm NE of Yen Bai on Ro	ute 13A.			
	DESCRIPTION:				
25X1	winth 40' approx.	MATERIAL Concrete and	l steel		
	Deck	LENGTH OF EACH SPAN	approx.		
	STATUS: Bridge repaired and serviceable for vehicular traffic.				
	COMPENSATIVE ACTION:				
	By-pass highway bridge.				
25X1

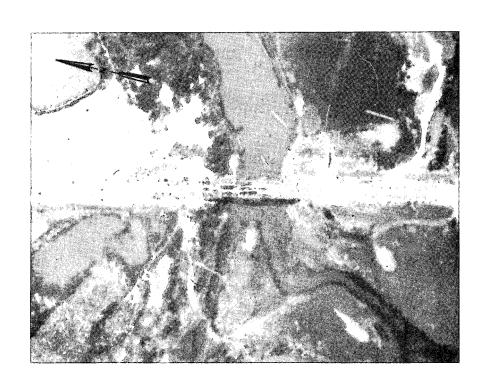
N AME		COUNTRY	COORDINATES
	Dong Son Bridge N	Hwy. Bridge No. 88 on NE 48-7	North Vietnam	18 37N - 105 31E XF 553590
(1				BRIEF NO: PIB 75296
	MAP	JOG (A) 1501 NE 48-	7	November 1966
,	LOCATION:	1.4 nm NW of Dong Son	on Route 72.	
4	DESCRIPTION	l: · · · · · · · · · · · · · · · · · · ·	**	
1	LENGTH		MATERIAL WOOD	
	WIDTH Type	10' approx. Deck	NO. OF SPANS 5

By-pass road and causeway.

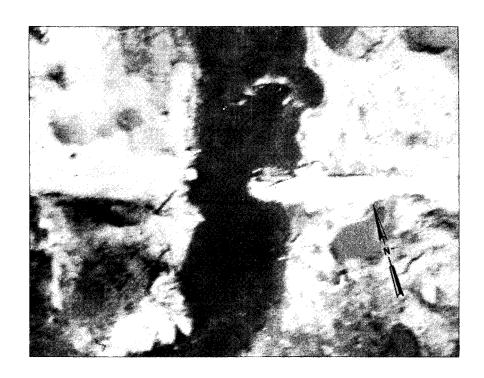
By-pass causeway and short timber span.

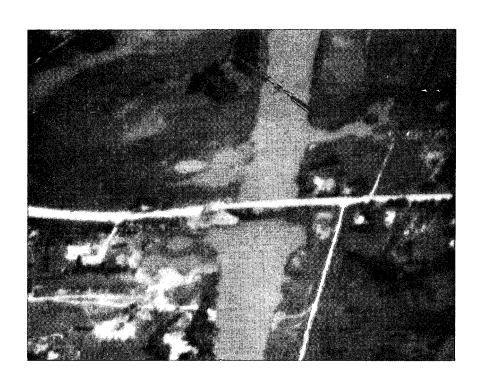
CIA IMAGERY ANALYSIS DIVISION				
NAME Vinh Hwv. Bridge S 2 over stream Bridge No. 37 on NE 48-7	COUNTRY North Vietnam	COORDINATES 18 37N - 105 40E WF 707599	 25X1	
MAP JOG (A) 1501 NE 48-7	Davida Q	BRIEF NO: PIB 75298 November 1966	25X1	
LOCATION: 0.4 nm SW of Yen Dong on	koute o.		25X1	
DESCRIPTION: LENGTH WIDTH TYPE Deck	material Concrete no. of spans 4 length of each span		25X1	
status: Repaired and serviceable.				
COMPENSATIVE ACTION:				
None			25X1

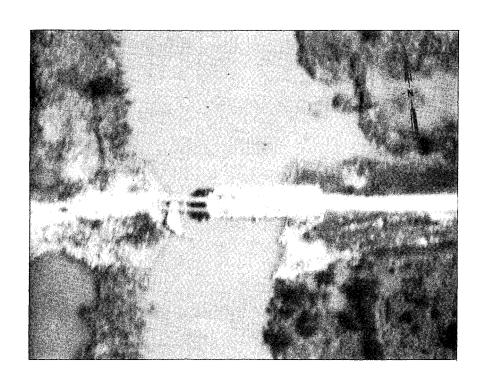
CIA IMAGE	RY ANALYSIS DIVISION		
•	NAME Hung Long Hwy. Bridge over	COUNTRY	COORDINATES	
25X1	Cau Song		18 23N - 105 47E	
	Bridge No. 71 on NE 48-7	North Vietnam	WF 843330	_
25X1			BRIEF NO:	
			PIB 75299	
	MAP JOG (A) 1501 NE 48-7		November 1966	
'	LOCATION: 0.8 nm W of Viet Xuyen on	Route 82.		
25X1	DESCRIPTION: LENGTH WIDTH TYPE Deck	material Concrete no. of spans 14 LENGTH OF EACH SPAN		25X1
25X1	Old span destroyed; replace bridge is serviceable.	ced by two temporar	ry wood spans;	25X1
	COMPENSATIVE ACTION:			
	None
